Tall Drink of Water: Challenges of Lining a Potable Water Tank

Rehabilitating a 20-million-gallon (75,708,236 L) potable water tank, which required removing an existing 30-year-old coating system using hydro demolition techniques and applying a copolymer plural component coating system

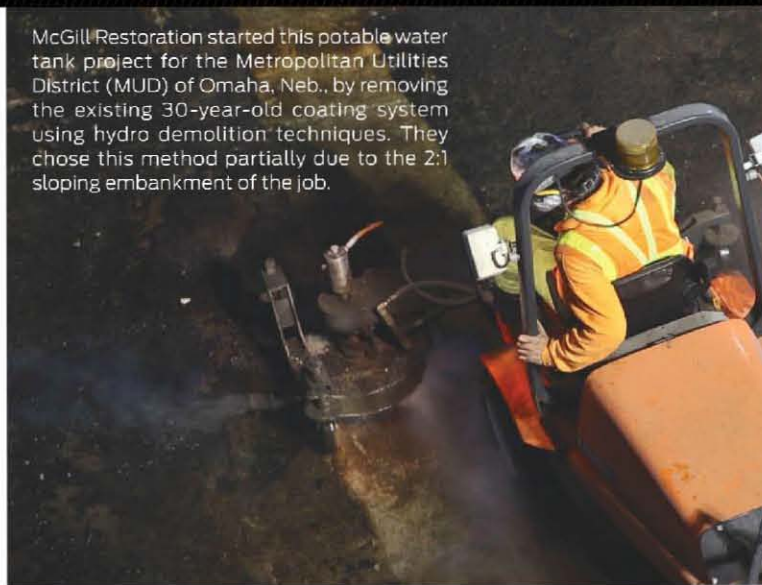
McGill Restoration started this potable water tank project for the Metropolitan Utilities District (MUD) of Omaha, Neb., by removing the existing 30-year-old coating system using hydro demolition techniques. They chose this method partially due to the 2:1 sloping embankment of the job.

To completely remove the old, cold tar urethane coating, McGill and his team decided to use hydro demolition. "We chose this method for two reasons: First, we could remove the existing coatings and profile the concrete in one pass. Second, about two-thirds of the substrate was a 2:1 sloping embankment. With the hydro demolition method, we were able to use a specialized hydraulic robot that climbed the embankment on a cable-driven system. The robot is manufactured by Blasters, Inc., and the hydro demolition pump is manufactured by Jetstream," explained McGill.

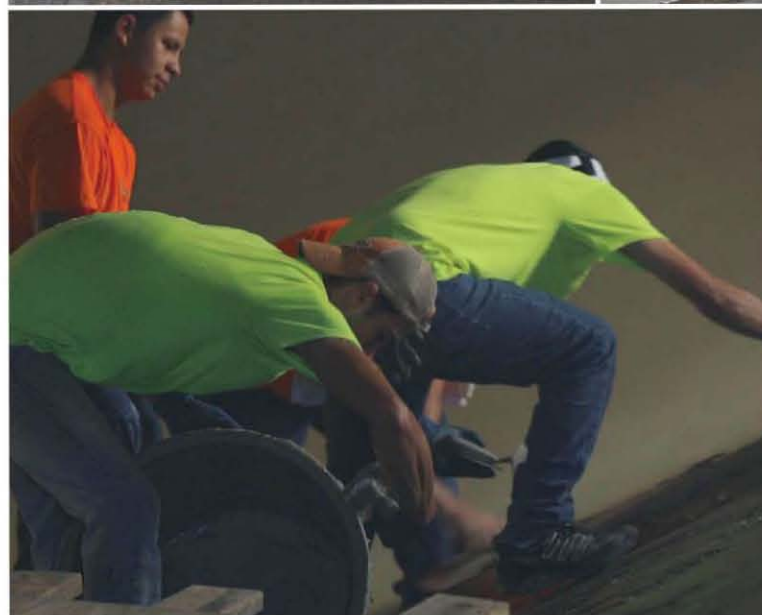
The 20-person coatings crew from McGill Restoration knew they would be working close to home — only about 1,000 yards (914 m) from their office, in fact. The job entailed applying a two-coat system, including two coats at an average of 5 mils (127 microns).

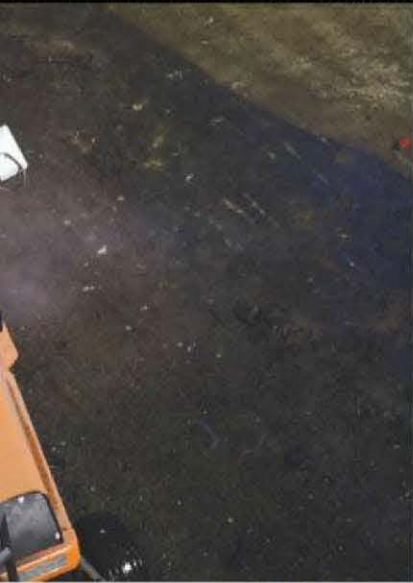
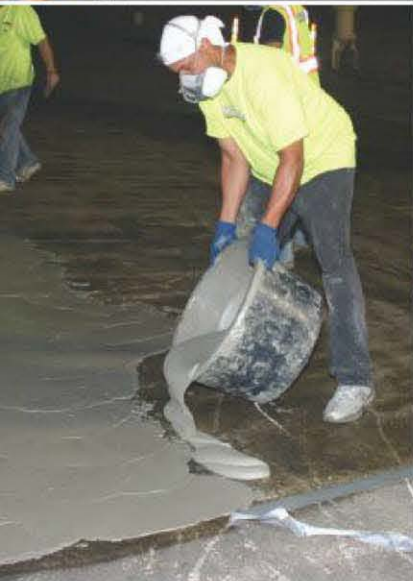
Wearing 3M respirators with isocyanide cartridges, safety glasses, and gloves, the crew spray-applied an additional coat of Polyprime 21 after the parge coat at an average thickness of 5 mils (127 microns). They then applied a 100 percent solids polyurea polyurethane copolymer on top.

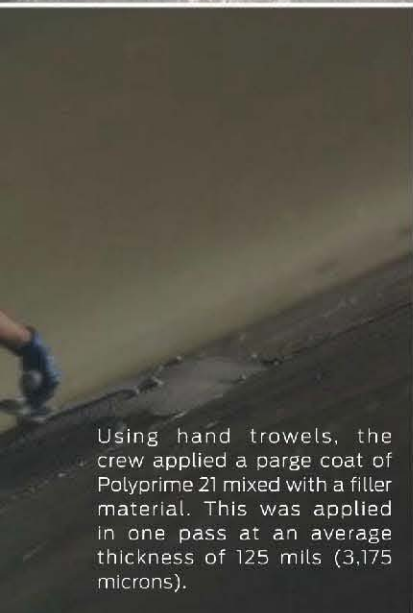
Using hand trowels, the crew applied a parge coat of Polyprime 21 mixed with a filler material. This was applied in one pass at an average thickness of 125 mils (3,175 microns).

With the moisture issues taken care of, the crew could finally get down to the business of installing the parge coat. "The parge coat is the same epoxy as the primer [Polyprime 21] with a filler material that is mixed in at 2.5 parts powder to 1 part epoxy. This makes the material have a mortar-like consistency," explained McGill. The crew hand-troweled the epoxy coating at a thickness of 125 mils (3,175 microns) in one pass. According to McGill, he and his crew were able to trowel approximately 6,000 square feet (557 m²) per working day, so the parge coat took a little over 20 days to apply.

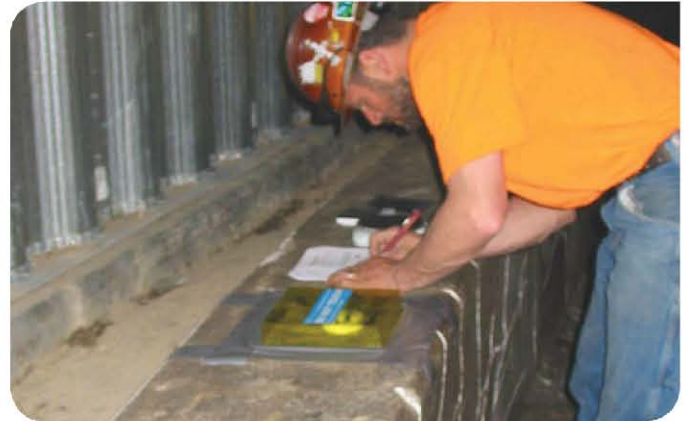
Hundreds of relative humidity tests were conducted by a third-party testing service on the concrete substrate. These moisture tests revealed extremely high levels of vapor drive within the substrate, which resulted in applying two coats of the primer to the entire substrate.

Hundreds of relative humidity tests were also conducted by Terracon, a third-party testing service, and were uniformly coming back much too high for coating application to commence. The moisture issues in the tank's interior needed to be addressed quickly so that the project could remain on schedule. As stated by McGill, this adjustment to the project specifications received buy-in from both MUD, as the asset owner, and

"Working with Polycoat Products, we decided to apply two coats of Polyprime 21 primer, a 90 percent solids NSF-approved epoxy, to some areas in the tank," said McGill. The crew once again conducted moisture tests, and this time the results were exactly what McGill had hoped for — no outgassing or bubbles occurred. Since the primer performed so well as a vapor block in these areas, the crew then installed two coats of Polyprime 21 throughout the entire water storage basin. Using a Graco Ultra Max II 1095 airless sprayer with a .035 tip, the crew laid down the primer at an average dry mil thickness of 5 mils (127 microns) per coat.

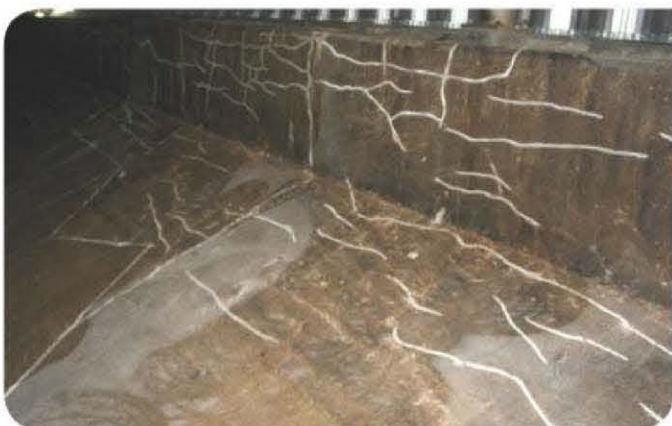
Although the crew found that the water basin was mostly sound, it did have some significant cracking. To mitigate those problems, the crew used a hydrophilic urethane grout injection to seal up actively leaking cracks, which were handled prior to the beginning of the coatings operation.

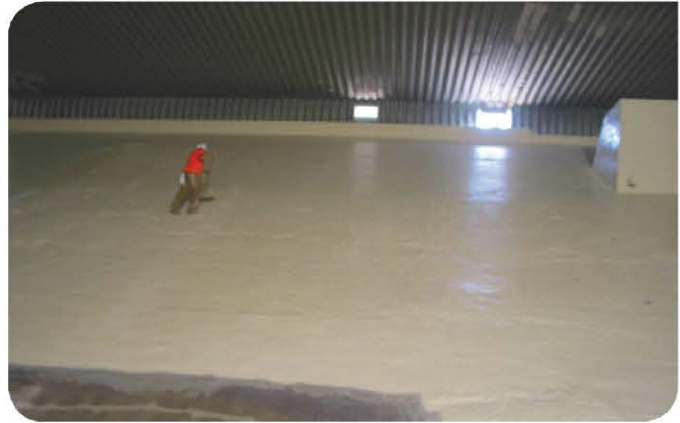
This 20-million-gallon (75,708,236 L) water basin covered 127,000 sq. ft. (11,799 m²). And the project, which lasted three months, highlighted products that are NSF-approved to meet the needs of potable water — water that this crew has been drinking and will be drinking for years to come!
