L.A. Confidential: Cracked Concrete At Police Headquarters

When Pacific Waterproofing & Restoration, Inc., of Pomona, Calif., is called to the parking structure of the police headquarters in downtown Los Angeles, the uncoated concrete is severely cracked, and the schedule for repairs and coating application is extremely aggressive. Can they solve the case of the cracked concrete before it's too late?

Repair cracked concrete and apply Polyprime 21 and Poly-I-Gard 246SC to the roof of the parking structure for the City of Los Angeles Police Headquarters

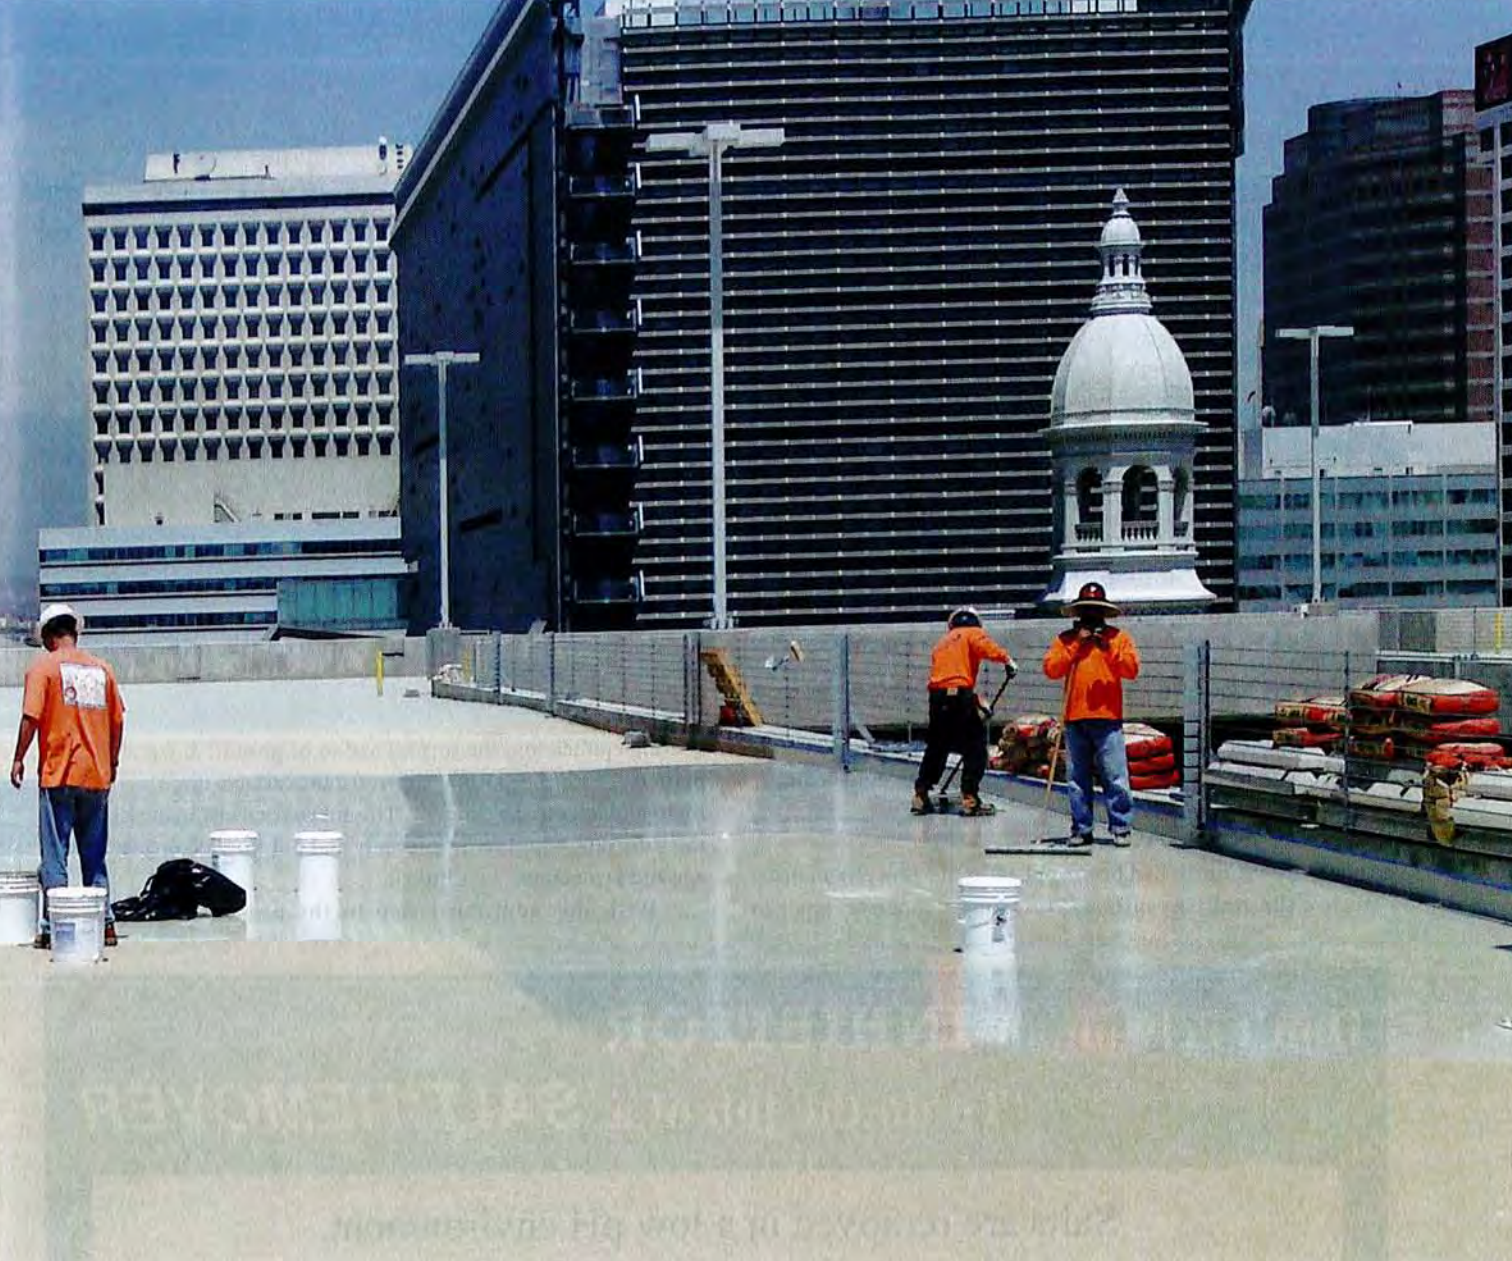
ABOVE ▲ Parsons explains, "Some of the cracks were 1/8" to 1/4" (0.32cm to 0.64cm) wide. Before any coating could be applied, the cracks needed to be repaired."

- EER, Inc., was called in to perform the surface preparation of the concrete. They removed all of the heavy trowel finish and then shot-blasted the entire roof area.
- The Pacific Waterproofing crew repaired the cracks by first opening up the cracks with a grinder with a diamond blade and then applying Sikaflex 2c NS EZ joint sealant. A detail coat of Poly-I-Gard 246SC was then applied to the area.
- Once all the cracks were repaired, the crew applied Polyprime 21 to the entire roof.
- An intermediate coat of Poly-I-Gard was applied, and sand was broadcast into the coating. In some areas, such as driving lanes, turn radiuses, and ramps, a second broadcast was done.
- The final top coat of Poly-I-Gard 246SC was then applied.

Repairing the many cracks in the concrete required a three-step process. First, a grinder with a diamond blade was used to open up the cracks. Then the cracks were primed and Sikaflex 2c NS

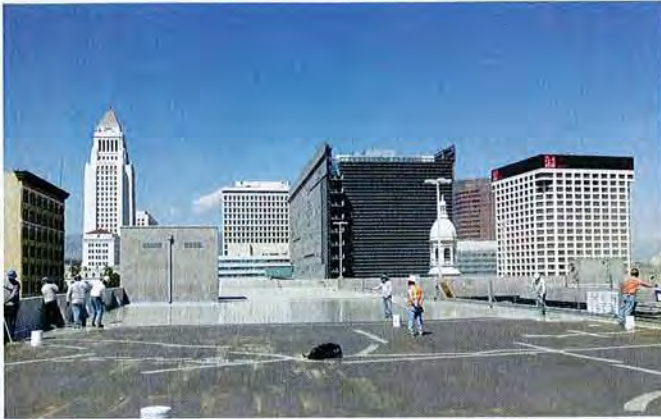
ABOVE ▲ Built in 2010, the 57,000 square feet (5,295.47m²) concrete roof of the parking structure for the police headquarters for the City of Los Angeles Police Department sees a lot of traffic. Left uncoated, after a year of exposure and heavy use, it was in need of protection.

Pacific Waterproofing was hired to repair all cracks in the uncoated concrete and apply Polyprime 21 primer and Poly-I-Gard 246SC basecoat to the roof and any other exposed areas. "Coating the concrete was an afterthought," says Bithell, "but once it became obvious that coating was necessary, we had to get in there quickly and fix the roof."

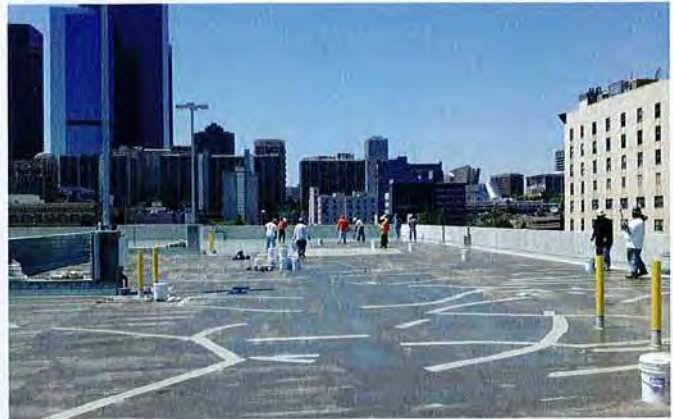
Bob Parsons of Polycoat Products, manufacturer of the coating system, concurs. "The surfaces were uncoated and in desperate need of repair," says Parsons. "Some of the cracks were 1/8" to 1/4" (0.32cm to 0.64cm) wide. Before any coating could be applied, the cracks needed to be repaired."

EZ joint sealant was installed. Sikaflex2c NS EZ is a two-component, non-sag, polyurethane-based elastomeric sealant. It has high elasticity and excellent adherence to concrete, and it provides good chemical and weather resistance.

The Pacific Waterproofing crew filled all cracks with the Sika joint sealant and then applied a detail coat of Poly-I-Gard 246SC over the newly repaired areas. "In some of the bigger cracks, we also installed a reinforcing fabric manufactured by Polycoat Products," says Bithell.

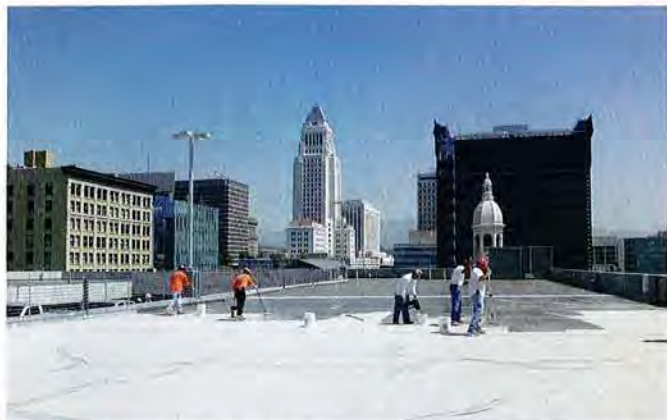
ABOVE ▲ "We called in EER Inc., of Pomona, Calif., to perform the surface preparation of the concrete," says Bithell. "They removed all of the heavy trowel finish and then shot-blasted the entire roof area."

The heavy trowel finish had been applied to the concrete in order to create a slip-resistant surface. Prior to any concrete repair or

coating application, the surface had to be ground down and shot-blasted. "With the existing slip-resistant surface, there were many highs and lows in the concrete. This means that any material put on the substrate would settle unevenly and not provide proper coverage and protection," says Bithell.

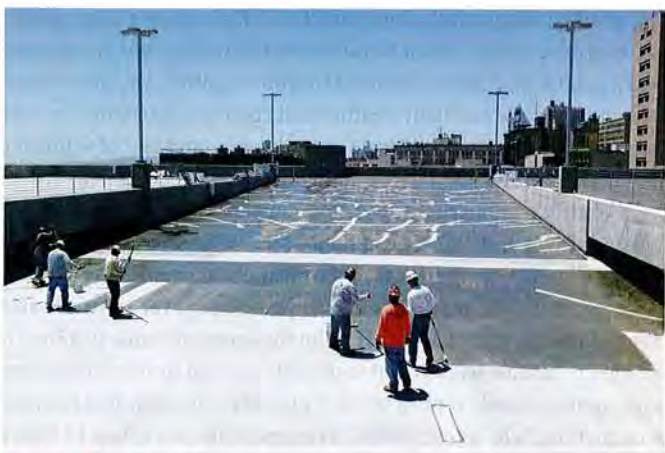
ABOVE ▲ With the clock ticking the crew divided the large deck into two sections, taking one week to prep both sections. Then they took one week per each section to repair the cracks and apply the coatings.

According to Bithell, the project was divided into two sections. It took approximately one week to prep both sections and one week per section to repair the cracks and apply the Polycoat Products coating system.

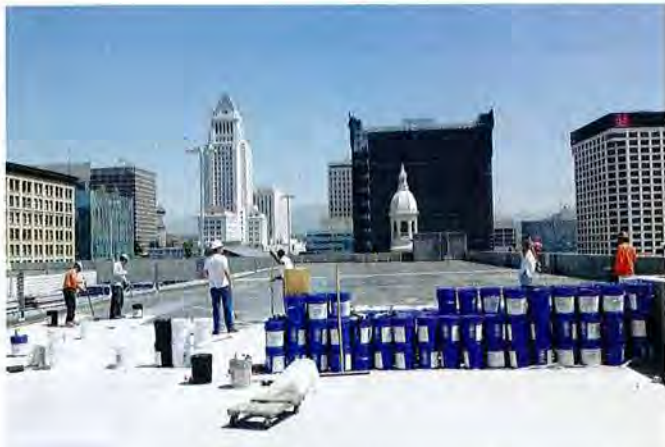
ABOVE ▲ The system specified for this high-profile project, Polycoat Products' Polyprime 21 and Poly-I-Gard 246SC are in compliance with South Coast Air Quality Management District (SCAQMD) strict low volatile organic compound (VOC) requirements.

For Bithell and his crew working on the roof of a downtown Los Angeles parking structure, the city sprawled out before them provided an excellent backdrop and created an additional challenge. The parking structure lies within the boundaries of the South Coast Air Quality Management District (SCAQMD). Fortunately, the chosen coating system, Polycoat Products' Polyprime 21 and Poly-I-Gard 246SC, meet Southern California's low volatile organic compound (VOC) requirements. Both are high solids coatings that

comply with the SCAQMD air quality standards. The SCAQMD regulates stationary sources of air pollution for most of Los Angeles, San Bernardino, Riverside, and all of Orange counties. This area encompasses approximately 10,750 square miles (27,842.37km²) and is the second most populated area in the United States. According to Parsons, coatings with a high percentage of solids contain a lower percentage of solvents. This means that high solids coatings, such as Polyprime 21 and Poly-I-Gard 246SC, have a lower percentage of solvents that will evaporate into the air and pollute the environment during the coating application. Parsons also points out that Poly-I-Gard 246SC is specially formulated to meet the stringent SCAQMD regulations.

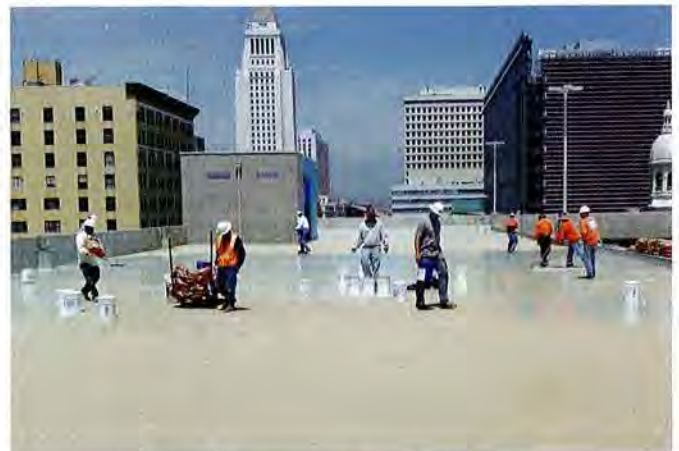
ABOVE ▲ The Pacific Waterproofing & Restoration, Inc. crew used squeegees to apply the Polyprime 21 primer to the substrate at a thickness of 5 mils (0.13mm) DFT. Following the pour, squeegee, and backroll application, the prime coat was allowed to cure for approximately six hours.

With a proper coating system chosen, the concrete surface ground down and shot-blasted, and all cracks repaired, the crew was finally ready to get down to the business of coating the parking structure roof. The Polyprime 21 was poured onto the substrate and applied using a squeegee at a dry film thickness of 5 mils (0.13mm). The area was then back-rolled to provide an even finish. The primer took approximately four to six hours to cure. The crew had to make sure that the Poly-I-Gard 246SC was applied no more than 12 hours after the primer became tack-free.

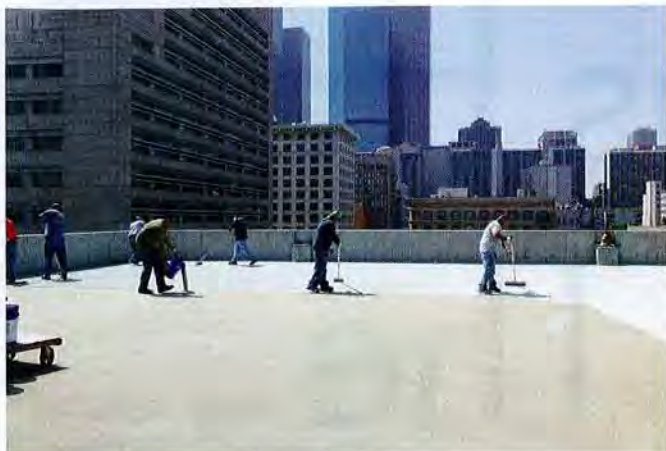
ABOVE ▲ An intermediate coat of Poly-I-Gard 246SC was squeegee-applied at a DFT of 11 mils (0.28mm). Following a sand broadcast, the topcoat was squeegeed, backrolled, and allowed to cure for 16 hours.

The Poly-I-Gard 246SC was poured out and applied at a dry film thickness of approximately 11 mils (0.28mm) using a squeegee.

Then sand was broadcast into this intermediate coat. According to Bithell, excess sand was swept up, and any residual sand and aggregate was blown off prior to the application of the top coat. "We also applied an extra sand broadcast coat to the drive lanes, turn radiuses, and ramps," says Bithell.

The topcoat was then applied and back-rolled to get rid of any marks in the coating that occurred during the application process.

The crew had to make sure that they allowed each coat to cure at least 16 hours before applying subsequent coats; however, any recoats had to be applied within 48 hours to ensure proper adhesion between coats.
