TECHNICAL BULLETIN #4

REPAIRING BLISTERS

THE PURPOSE OF THIS TECHNICAL BULLETIN IS TO DISCUSS THE NATURE AND REPAIR OF BLISTERS IN AN ELASTOMERIC DECK COATING SYSTEM (WHAT CAUSES THEM AND HOW TO FIX THEM).

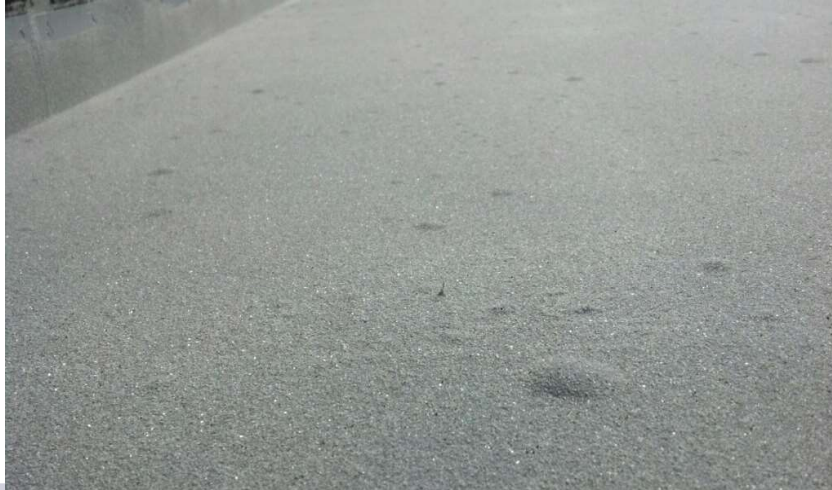
Blisters are typically caused by over-application (too thick an application) of the coating. They may also be caused by the application of the coating over a damp surface. This includes aggregate that has been exposed to moisture (rain or mist) that has not been allowed to dry thoroughly. Finally, blisters may be caused by application of the basecoat over uncured primer.

1. Cut or grind out the blister to a point where the coating is bonded.
2. Flat blade a manufacturer-approved polyurethane sealant into the cavity and sprinkle aggregate onto the wet sealant to match the aggregate profile of the surrounding deck coating. Let this patch cure overnight
3. Apply top coat to the aggregate to match the surrounding deck coating. The topcoat should be feathered onto the area surrounding the patch.
